*Perspective*

## Restoration of Accelerator Facilities Damaged by Great East Japan Earthquake at Cyclotron and Radioisotope Center, Tohoku University

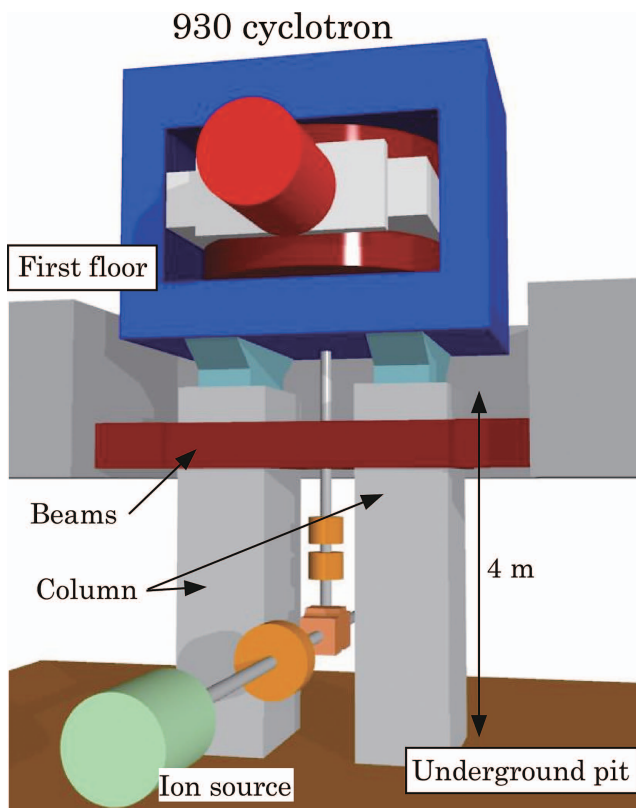
Fig. 2. 930 cyclotron with columns.

The 930 cyclotron was installed on two columns (4 m in height and  $1.7 \times 0.8 \text{ m}^2$  each in cross section) made of steel-reinforced concrete (Fig. 2). The columns were driven deeply into the bedrock of Aobayama, independently from the foundation of the cyclotron building, to support the 930 cyclotron, which weights 250 t. In addition, when the 930 cyclotron was updated in 1999, beams were added to the upper part of the columns to suppress horizontal movement in preparation for the next possible Miyagiken-oki earthquake. In this earthquake, the columns were greatly damaged above the beam level (Fig. 3). Damage not only

The 930 cyclotron is placed on two columns made of steel-reinforced concrete. The columns are held by the beams, which embedded in the first floor, to suppress horizontal movement in earthquakes.

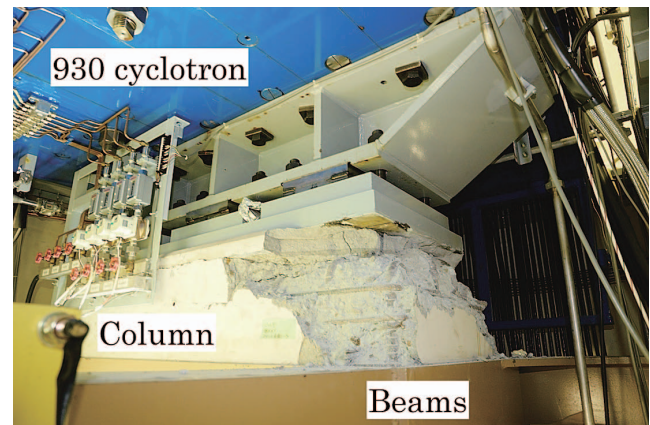
Fig. 3. Damaged cyclotron column.

appeared in the mortar of the column surface but also reached the internal concrete, so we could even see the reinforcing bars. As a result, the 930 cyclotron was inclined by about 5 mm.

The columns on which the 930 cyclotron was placed were partly damaged. A part of the mortar of the column surface peeled off and the internal concrete were also damaged. The damage of the columns appeared only above the beams. This indicated that the columns were shaken with the building, while the 930 cyclotron were shaken differently from the building.

The most important restoration activity was the repair of the columns on which the 930 cyclotron was placed. Depending on the repair method, we had to dismantle and remove the 930 cyclotron. Owing to the structural limitations of the building, we could neither leave the dismantled yoke and other components on the floor of the cyclotron room nor bring them out through the somewhat small opening of the shielding door. To dismantle and remove the cyclotron, we needed to reopen the carry-in entrance of the cyclotron room (which was filled with concrete 5 m in thickness after the cyclotron was installed). This also made it necessary to temporarily change the radiation controlled area. Therefore, before the repair work, we examined the strength of the columns. Fortunately, there was no problem with their strength, and it was not necessary to considerably elevate the 930 cyclotron while repairing the columns.

part of the columns, grout was injected to repair them. Here, we attempted to apply the weight of the cyclotron to the columns; as a result, the base plate on top of the column deformed, and gaps appeared between the plate and the column at both ends of the plate. The degree of deformation changed when we put the load back on, and the horizontal level of the 930 cyclotron changed. Therefore, to eliminate the bending deformation, holes of about 5 mm were bored at 20-cm intervals around the column in the absence of the weight of the cyclotron; epoxy resin was injected to glue and fix the plate and the columns. At the same time, the

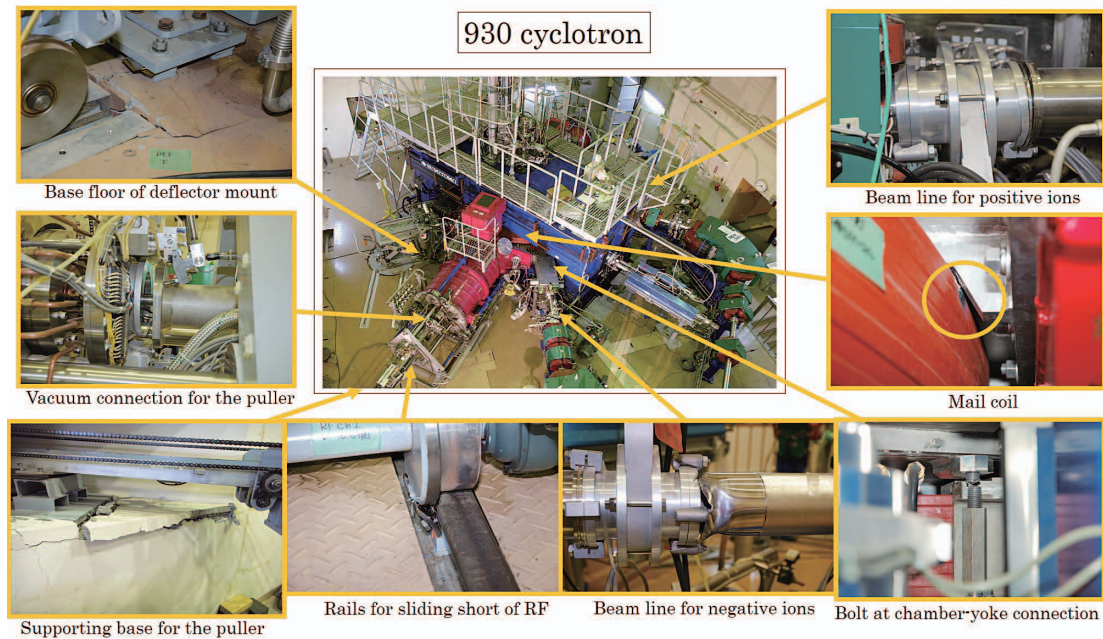
Fig. 4. Damage around 930 cyclotron.

Fig. 4 shows the damage in the areas surrounding the 930 cyclotron. Damage was obvious in the devices connecting the 930 cyclotron and the room floor: the puller system, deflector mount, and RF resonator. The vacuum junction came off of the puller system, and the locking mechanism was damaged. The mortar of the support base collapsed, and the drive unit also came off. In the deflector, the floor that fixes the support base was damaged, and the guides for the deflector mount were deformed. In the RF-related components, the rail attachment parts for the resonator were fractured, and the axle of the resonator support was deformed. In the RF amplifier, most of the bolts connecting the amplifier housing to the resonator were damaged and fell out, and the copper sheet for wiring in the housing was torn. The damage indicated that the 930 cyclotron on the columns was shaken differently from the peripheral devices fixed to both the cyclotron and the room floor.

The base floor of deflector mount, which was fixed both the 930 cyclotron and the base floor, was damaged. The connecting devices of the puller system came off. The mortar of the support base for the puller system collapsed. Rails for the shielding short of RF resonator were fractured. Beam ducts for both negative and positive ions were disconnected and deformed. A bolt connecting the acceleration chamber and yoke was broken. Some parts of the main coil were burned.

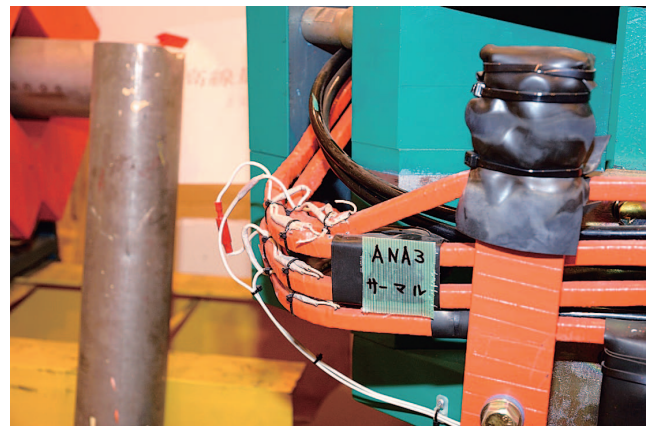
Fig. 5. Electromagnet damaged by falling object.

The damage to the beam transport lines was similar to that to the beam extraction lines; seven beam ducts came off and were damaged. When the ducts fell off, the atmosphere instantaneously flowed into the beam line, and some vacuum pumps were damaged. In some electromagnets, the coils were damaged by striking the claw clamps for connecting the beam ducts in the shaking of the earthquake or partially damaged by a falling body (Fig. 5).

Some electromagnets were partly damaged by a falling object. In this figure, the distortion of the top hollow conductor is obvious. The falling object was stored on top of a shielding blocks without fall-prevention measures.

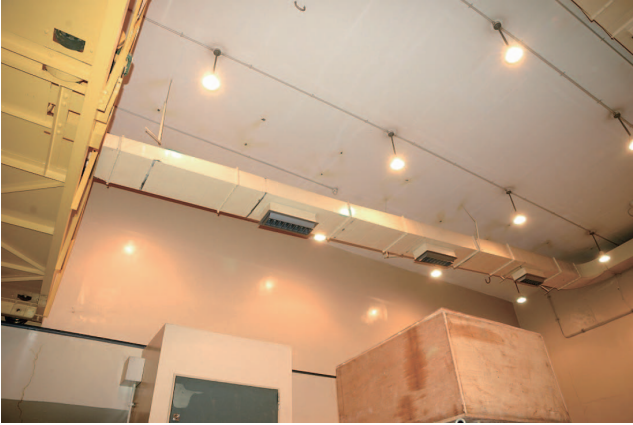
In the electromagnet room where the beams are transported to target rooms, the hanging columns of the ventilation duct fell, and the ducts dropped (Fig. 6). Fortunately, the duct stopped on the beam of the overhead traveling crane and did not fall further onto the beam line, which therefore remained in place.

Fig. 6. Ventilation duct that fell onto the ceiling crane.  
In the electromagnet room, the hanging columns of the ventilation duct fell, and the duct dropped. The duct stopped on the ceiling crane and did not fall onto the beam line. Consequently, further damage of the beam line was prevented.

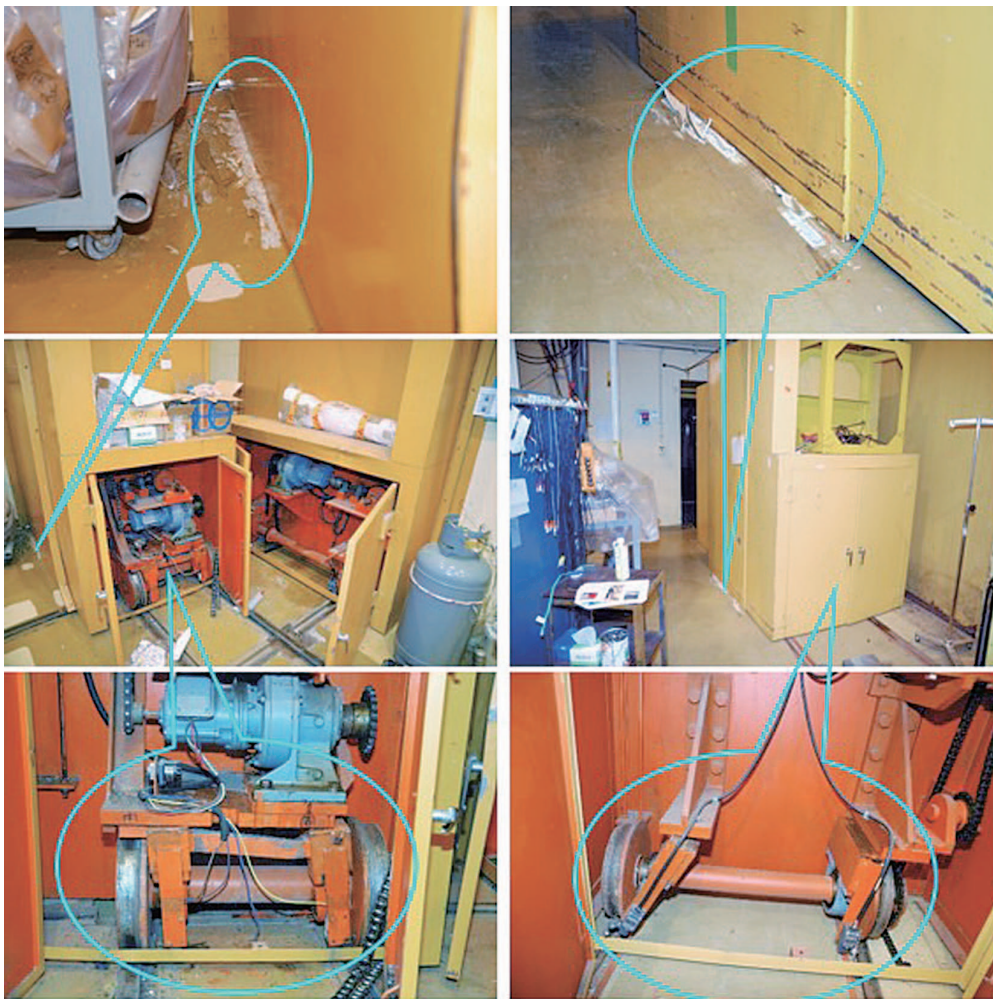
drive components for two shielding doors (8 and 10 for target rooms 2 and 1) were severely damaged by lateral vibration, and the doors, each weighing 15-20 t, fell from the carriage onto the floor (Fig. 7). The two doors blocked the entrances to the target rooms and made it impossible to bring in heavy machinery and materials needed for the restoration work. In the shielding doors in two other places, the drive chains were torn, indicating that the shielding doors rocked on the rails during the earthquake. In the six

Fig. 7. Damaged shielding door.  
Drive component was completely destroyed, and main body of the door fell onto the floor. The doors blocked the entrances to the target rooms and made it impossible to bring in heavy machinery needed for the restoration work.

The repair work on the shielding doors began at the end of July 2011. Our goal was to repair the two shielding doors for which the drive components were completely destroyed and fell onto the floor of the respective rooms. Each shielding door was situated at the entrance of the target room, where the concrete door, 2 m long and 15 t in weight, slides perpendicularly along the wall surface, leaving only a small gap of 5 mm between the wall and the door. It was possible that opening and closing the door might become impossible unless its central axis was very well aligned with the opening area in the wall. Since the load capacity of the crane in the target room is only 2.8 t and there was no way to bring in large machinery through the narrow stairway, it was impossible to lift the shielding door blocking the entrance. In this situation, the first idea was to dismantle the shielding door on the spot, remove it, and make a new one. However, this method would produce a large amount of waste and powder dust in the radiation controlled area. Therefore, we looked for a way to somehow lift the shielding door on the spot without dismantling it, exchange the destroyed drive component, and fine-tune the position. To lift the door, we made full use of chain blocks, jacks, and, when needed, the beam of the crane. Shielding doors (8) and (10) indicated in Fig. 1, were repaired by this method, and the position of each door was adjusted precisely by millimeter increments.

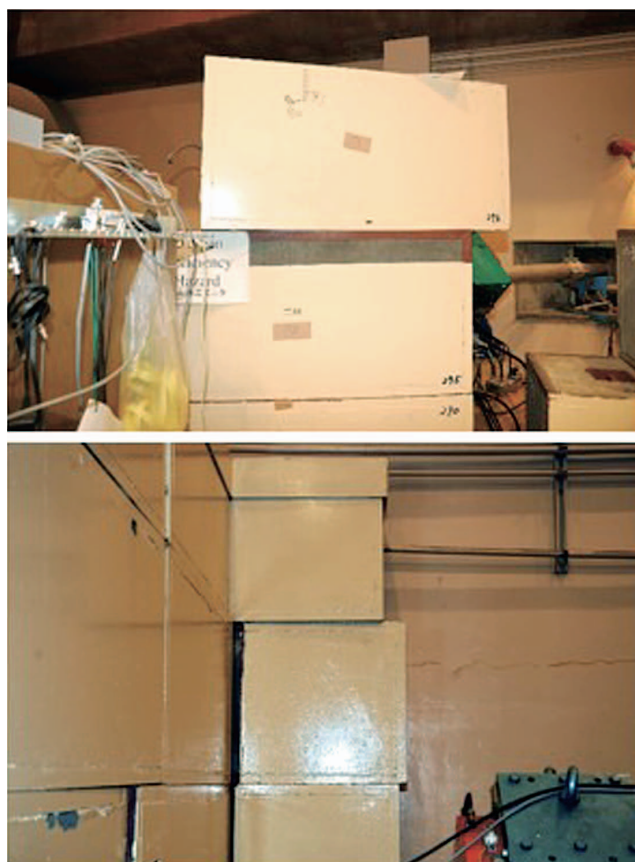
Fig. 8. Mismatch between shielding blocks.

In each target room, concrete blocks ( $100 \times 50 \times 50 \text{ cm}^3$ ) are bound together and piled up to strengthen the radiation shielding. Additional measures were taken to prepare male-female rods or frames to bind these shielding blocks at intervals, in anticipation of a Miyagiken-oki earthquake. Although the blocks did not fall thanks to these measures, ten blocks that had no frames slipped out of place (Fig. 8). The deviation was probably caused by the loose tolerance of the holes in which the rods were fitted.

In each target room, concrete blocks ( $100 \times 50 \times 50 \text{ cm}^3$ ) are piled up to strengthen the radiation shielding. The shielding blocks are bound together with male-female rods. Thanks to the measure, the shielding blocks did not fall but slipped out of place within the tolerance of the rods.

Anti-earthquake measures were then applied in each target room to improve the performance of the shielding concrete blocks that showed displacement due to the shaking of the earthquake. Because no displacement occurred in the blocks piled in an integrated manner using frames and beams, it was decided to adopt the use of frames and beams to bind all of the blocks in the target rooms.

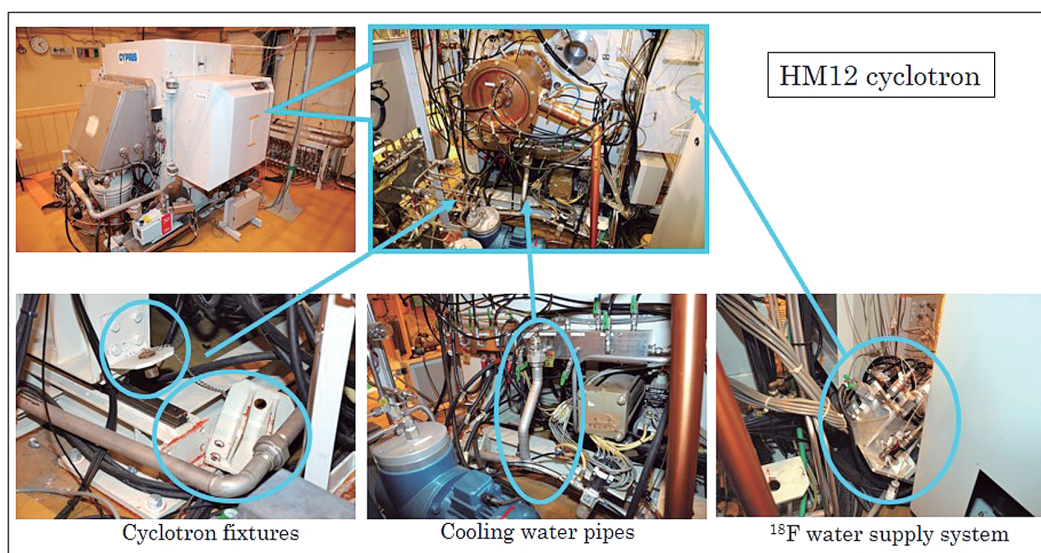
Fig. 9. Damaged HM12 cyclotron.

In this earthquake, great shaking continued for a long time, and the entire yoke rocked on the rails; as a result, the lock pins that fix the yoke and their attachment parts were broken. In addition, damage occurred in the connections with the peripheral devices fixed to the floor and the HM12 cyclotron, which rocked on the rails because of the damage to the lock pins. Specifically, the coolant pipe was deformed and came out of the header, and the pipe support fixings were fractured. In the RF devices, the waveguides were partly damaged, and the cable bearer for pipes and

The HM12 cyclotron is placed on the rails to allow for easy maintenance. In this earthquake, the HM12 cyclotron rocked on the rails, and consequently the cyclotron fixtures were damaged. Pipes of the cooling water was deformed and came out. The water supply system for  $^{18}\text{F}$  fell off of the stand.

wiring was damaged. Further, the water supply device for  $^{18}\text{F}$  fell off of the support, and the drive system and solenoid valves were damaged. Defects were also found in the compensator drive system. Fig. 9 illustrates the damage to the HM12 cyclotron.
