*Perspective*

## Restoration of Accelerator Facilities Damaged by Great East Japan Earthquake at Cyclotron and Radioisotope Center, Tohoku University

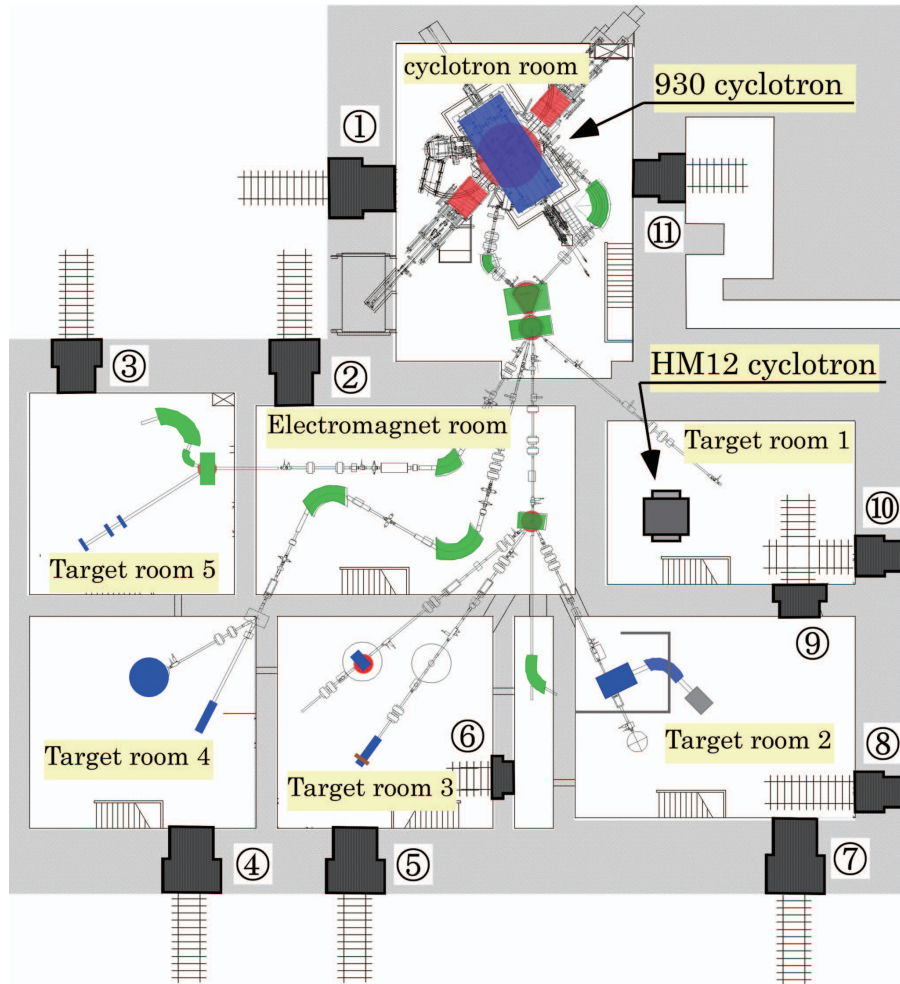
Fig. 1. Cyclotron facilities at CYRIC.

The 930 cyclotron is located at the cyclotron room, whereas the HM12 cyclotron is situated at the target room 1. Accelerated ions from the 930 cyclotron are transported to any one of nine beam lines in five target rooms. The numbers in a circle are a reference number for each shielding door.

The shielding doors showed the heaviest damage in the target rooms. Shielding doors, numbered 8, 10, and 11 in Fig. 1, were open when the earthquake occurred. The

The repair work on the shielding doors began at the end of July 2011. Our goal was to repair the two shielding doors for which the drive components were completely destroyed and fell onto the floor of the respective rooms. Each shielding door was situated at the entrance of the target room, where the concrete door, 2 m long and 15 t in weight, slides perpendicularly along the wall surface, leaving only a small gap of 5 mm between the wall and the door. It was possible that opening and closing the door might become impossible unless its central axis was very well aligned with the opening area in the wall. Since the load capacity of the crane in the target room is only 2.8 t and there was no way to bring in large machinery through the narrow stairway, it was impossible to lift the shielding door blocking the entrance. In this situation, the first idea was to dismantle the shielding door on the spot, remove it, and make a new one. However, this method would produce a large amount of waste and powder dust in the radiation controlled area. Therefore, we looked for a way to somehow lift the shielding door on the spot without dismantling it, exchange the destroyed drive component, and fine-tune the position. To lift the door, we made full use of chain blocks, jacks, and, when needed, the beam of the crane. Shielding doors (8) and (10) indicated in Fig. 1, were repaired by this method, and the position of each door was adjusted precisely by millimeter increments.
